CCTV DRAINAGE INSPECTION

Customer;
Alderminster Parish Council

Site Address;
A3400 Main Road
Alderminster
Warwickshire

Re; Culvert Inspection; A3400 Main Road, Alderminster, Warwickshire

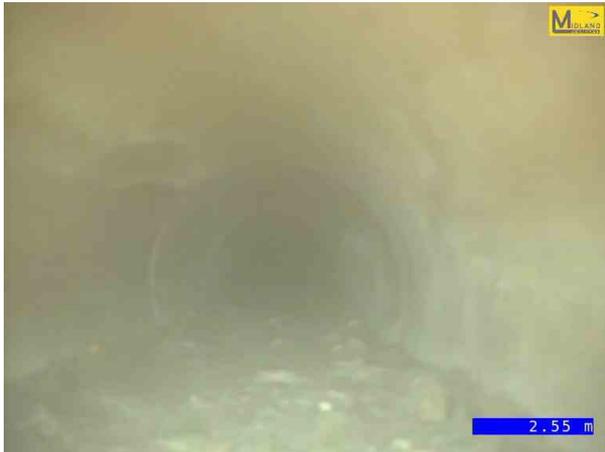
HW 1 -
 OUTFALL_f040dd7a-b90f-4301-ac4e-90aad8d680d6_202209
 21_121948_995.jpg, 00:00:13, 2.92 m
 Settled deposits, fine, 10% cross-sectional area loss, start

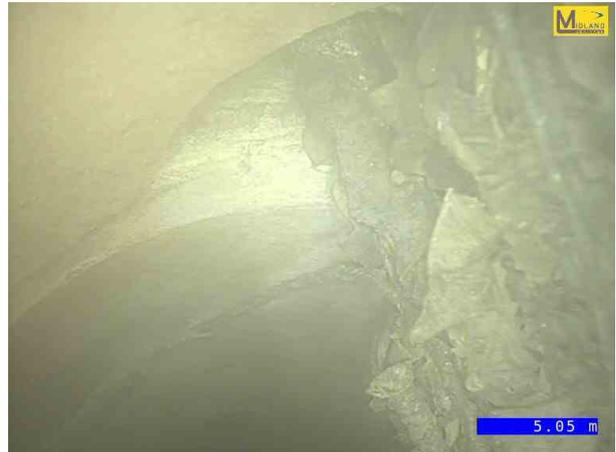
An attempt was made to inspect the outfall route from the headwall; a broken section and fracture is visible at circa 5.05 metres; following this, at circa 14.41 metres, the pipe diameter reduces to 150mm, at this point the camera unit is unable to proceed as it cannot pass the pipe reduction.

HW 1 -
 OUTFALL_2b0c78da-8fd5-4cc5-9e40-cb0a48c0ca0f_2022092
 1_121954_050.jpg, 00:00:40, 5.05 m
 Broken pipe at joint, at 5 o'clock

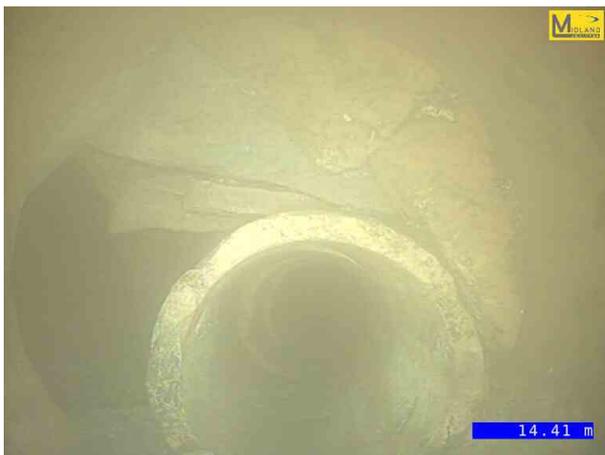
HW 1 - OUTFALL_0001.jpg, 00:02:21, 14.41 m
 Pipe size changes, new size(s), 150 mm high

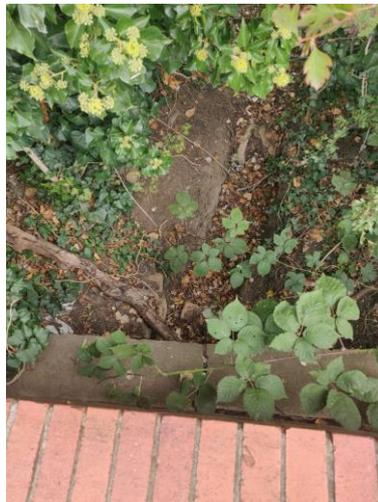
Headwall outlet;

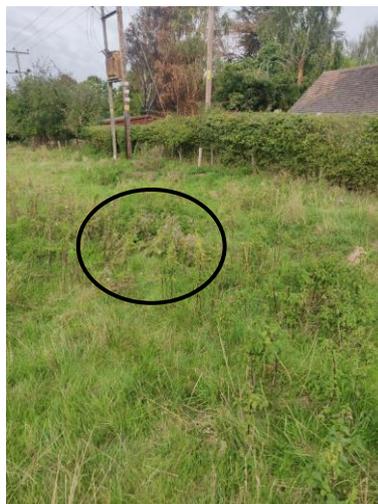
An inspection was made of the field area in which the route travels; it can be seen that there is a broken section of brickwork, in a collapsed state - this would be a major contribution toward the satisfactory operation of the route.

Route of culvert; location of collapse;

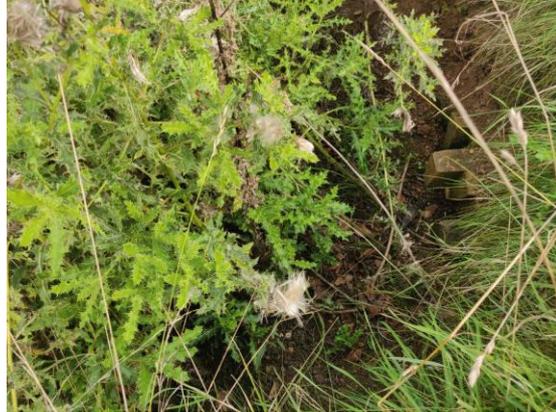
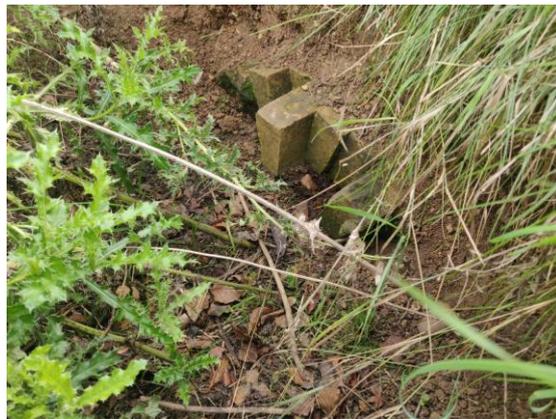
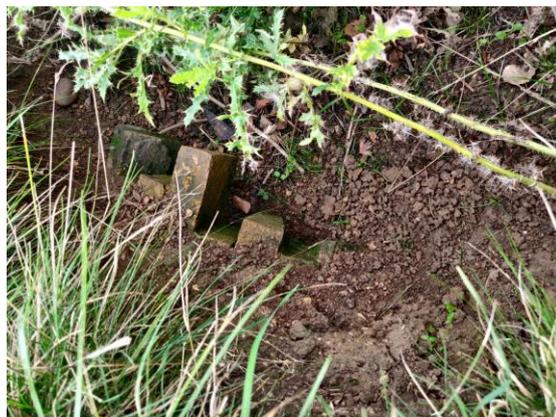
Views to show collapsed culvert;
