CCTV DRAINAGE INSPECTION

Customer;
Alderminster Parish Council

Site Address;
A3400 Main Road
Alderminster
Warwickshire

Re; Culvert Inspection; A3400 Main Road, Alderminster, Warwickshire

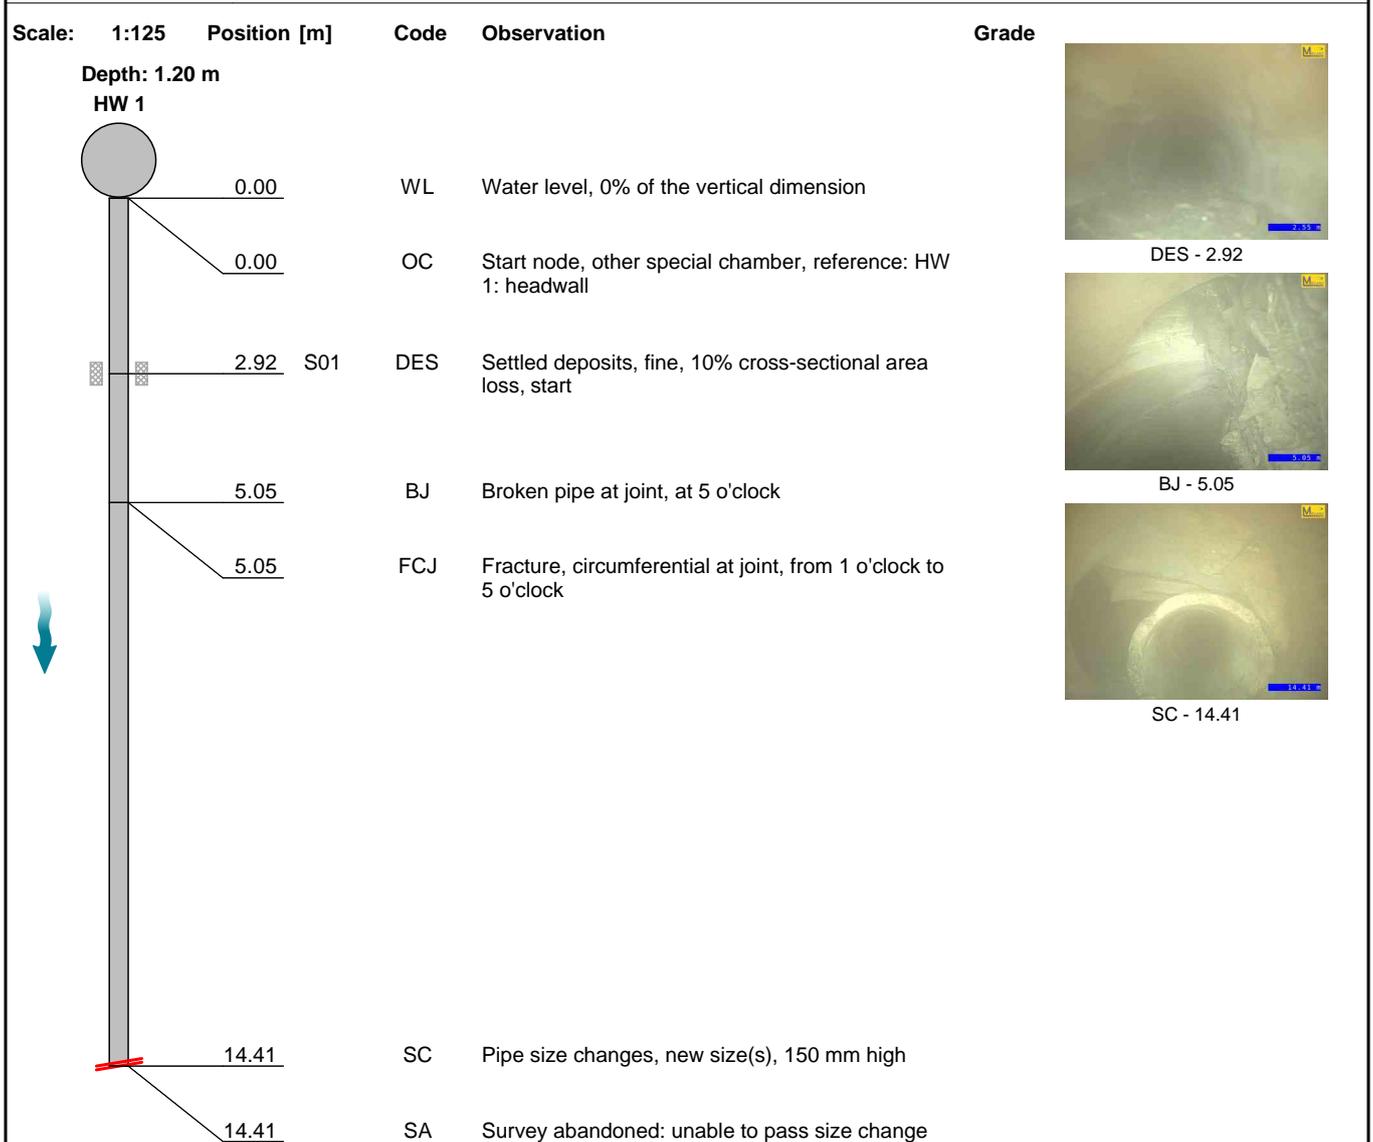
Town or Village: Alderminster	Inspection Direction: Downstream	Upstream Node: HW 1
Road: A3400	Inspected Length: 14.41 m	Upstream Pipe Depth: 1.200 m
Location: Verge	Total Length: 14.41 m	Downstream Node: OUTFALL
Surface Type:	Joint Length:	Downstream Pipe Depth:
Use: Culverted watercourse	Pipe Shape: Circular	
Type of Pipe: Gravity drain/sewer	Dia/Height: 225 mm	
Flow Control: No flow control	Material: Vitrified clay	
Year Constructed: Not Specified	Lining Type: No Lining	
Inspection Purpose: Investigation of operational problems	Lining Material: No Lining
